# EMERGENCY EXTRACTION DOCUMENT

## NORTH AMERICAN F-100F SUPER SABRE

Collings Foundation / Vietnam War Flight Museum

| Document status | WORKING DRAFT — aircraft-specific procedure verification required |

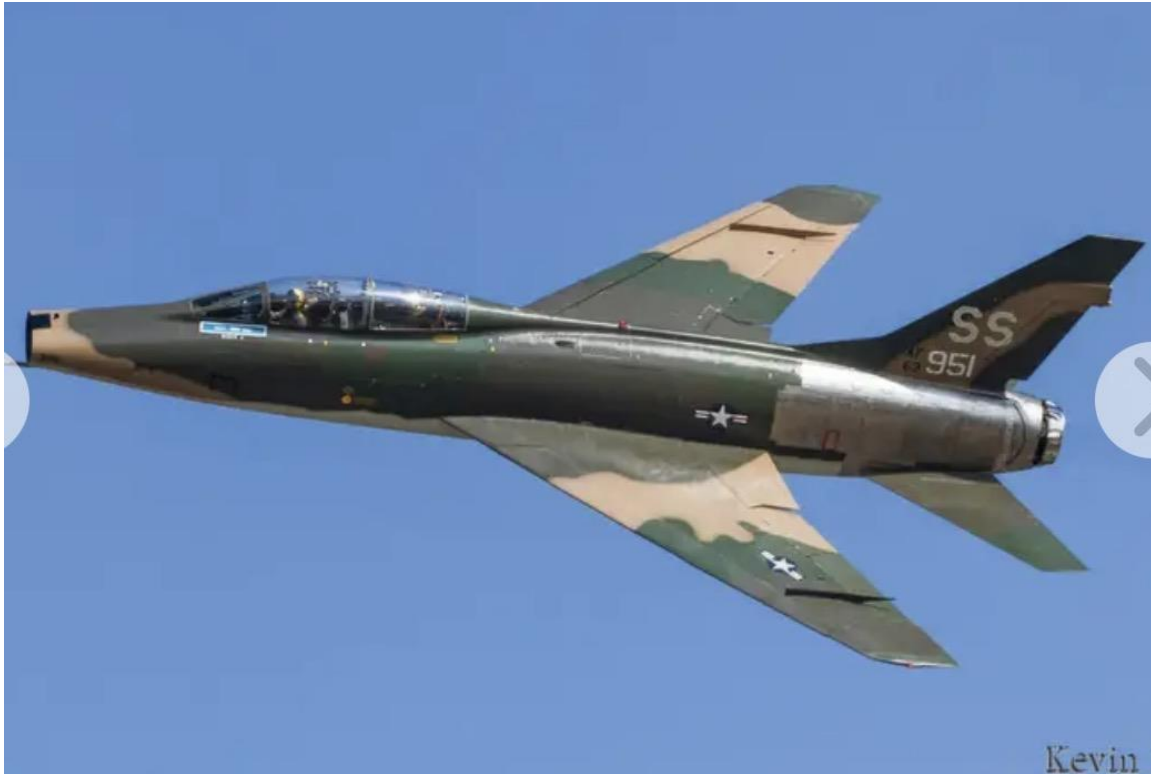
AIRCRAFT OVERVIEW - LEFT SIDE (PHOTO 1)

| ITEM | RESPONDER INFORMATION |
|---|---|
| Crew | 1 — front-seat occupant only; no aft crewmember carried |
| Engine | 1 × Pratt & Whitney J57-P-21A turbojet with afterburner |
| Fuel | Jet fuel. VERIFY actual fuel load/tank configuration and typical airshow configuration. |
| Ejection system | Front ejection seat is occupied. Treat it and canopy-jettison system as LIVE until safed. Confirm the status of any aft-seat ejection hardware that remains installed. |
| Oxygen | NONE ON BOARD — current N26AZ operating configuration carries no oxygen system/bottles onboard. |

**VERIFY ON AIRCRAFT** — Mark exact hazardous-system locations directly on the photograph above. Do not rely only on historical F-100 drawings.

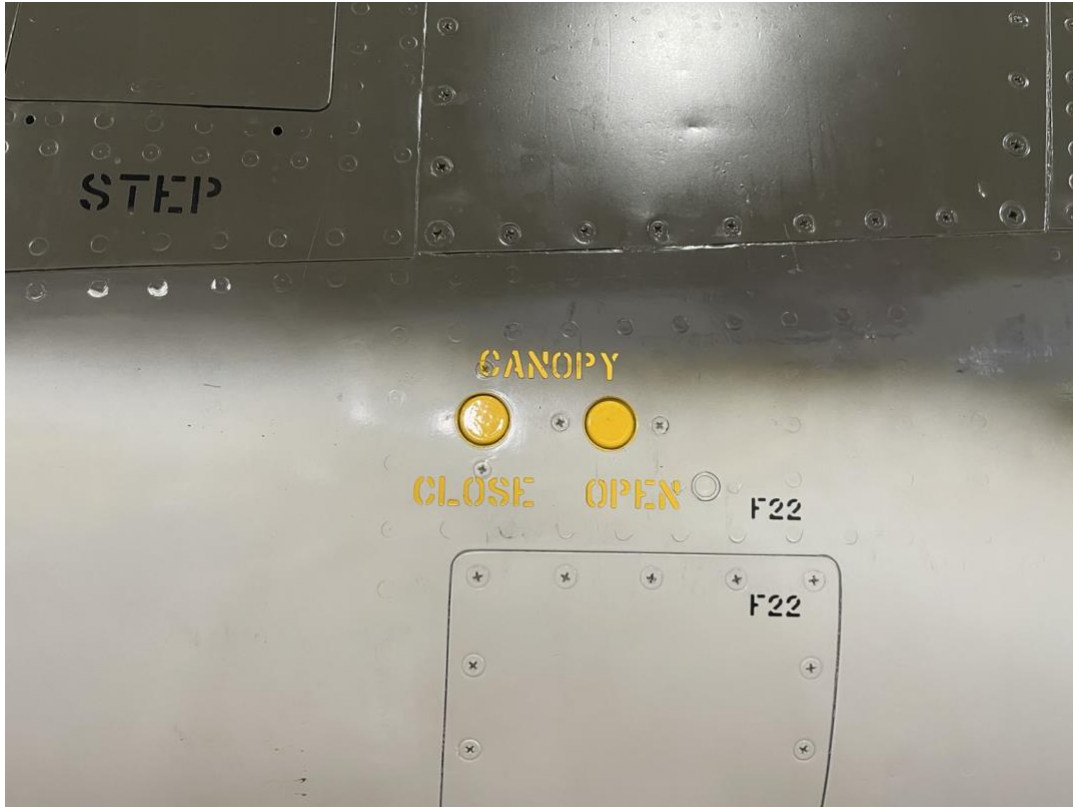
**PHOTO A — EXTERNAL CANOPY OPEN / CLOSE CONTROLS — LEFT FORWARD FUSELAGE**

**ACTUAL N26AZ INSTALLATION:** Two yellow pushbuttons are marked CANOPY CLOSE and OPEN. The OPEN pushbutton is the right-hand button in this photograph. Responders should verify operation during the pre-show aircraft walk-around before relying on electrical canopy opening in an emergency.

- **NORMAL ENTRY:** Locate the external canopy-open switch on the left side of the fuselage forward of the canopy. Operate only if conditions permit, then raise/open canopy fully.
- **MANUAL ENTRY:** Identify the canopy manual-release handle(s) and demonstrate the exact release direction/sequence on N26AZ.

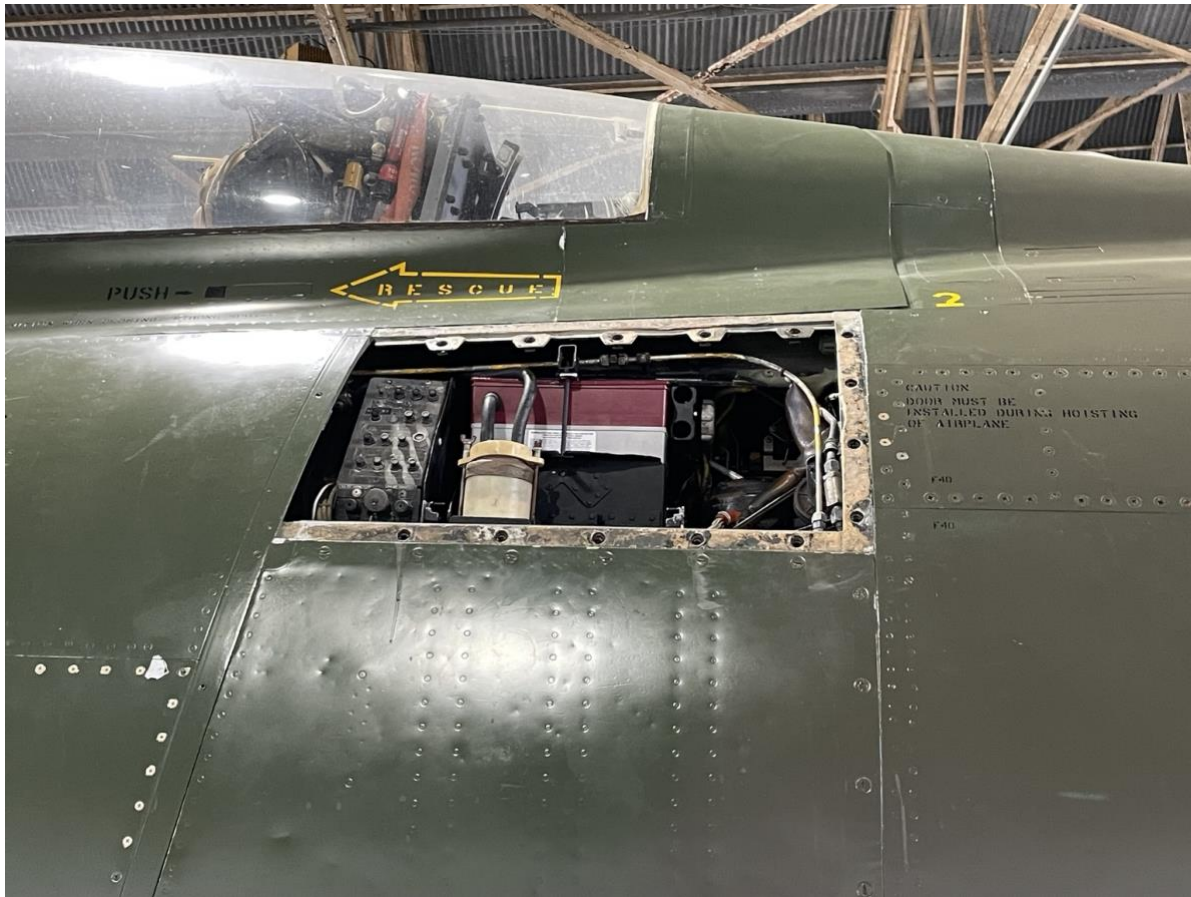
Aircraft-specific close-up of the right-side electrical control panel. The BATTERY switch is clearly labeled near the upper right of the panel. AC GENERATOR, DC GENERATOR, and START/STOP ignition controls are visible for responder orientation. Use only the controls specifically identified in the approved shutdown procedure.

**Battery access bay - left forward fuselage beneath canopy. Access panel removed/open; installed battery visible.**

**RESPONDER NOTE:** Use this photograph for battery-location identification only. Do not disconnect or manipulate battery leads until the aircraft-specific disconnect procedure is verified by the aircraft crew.

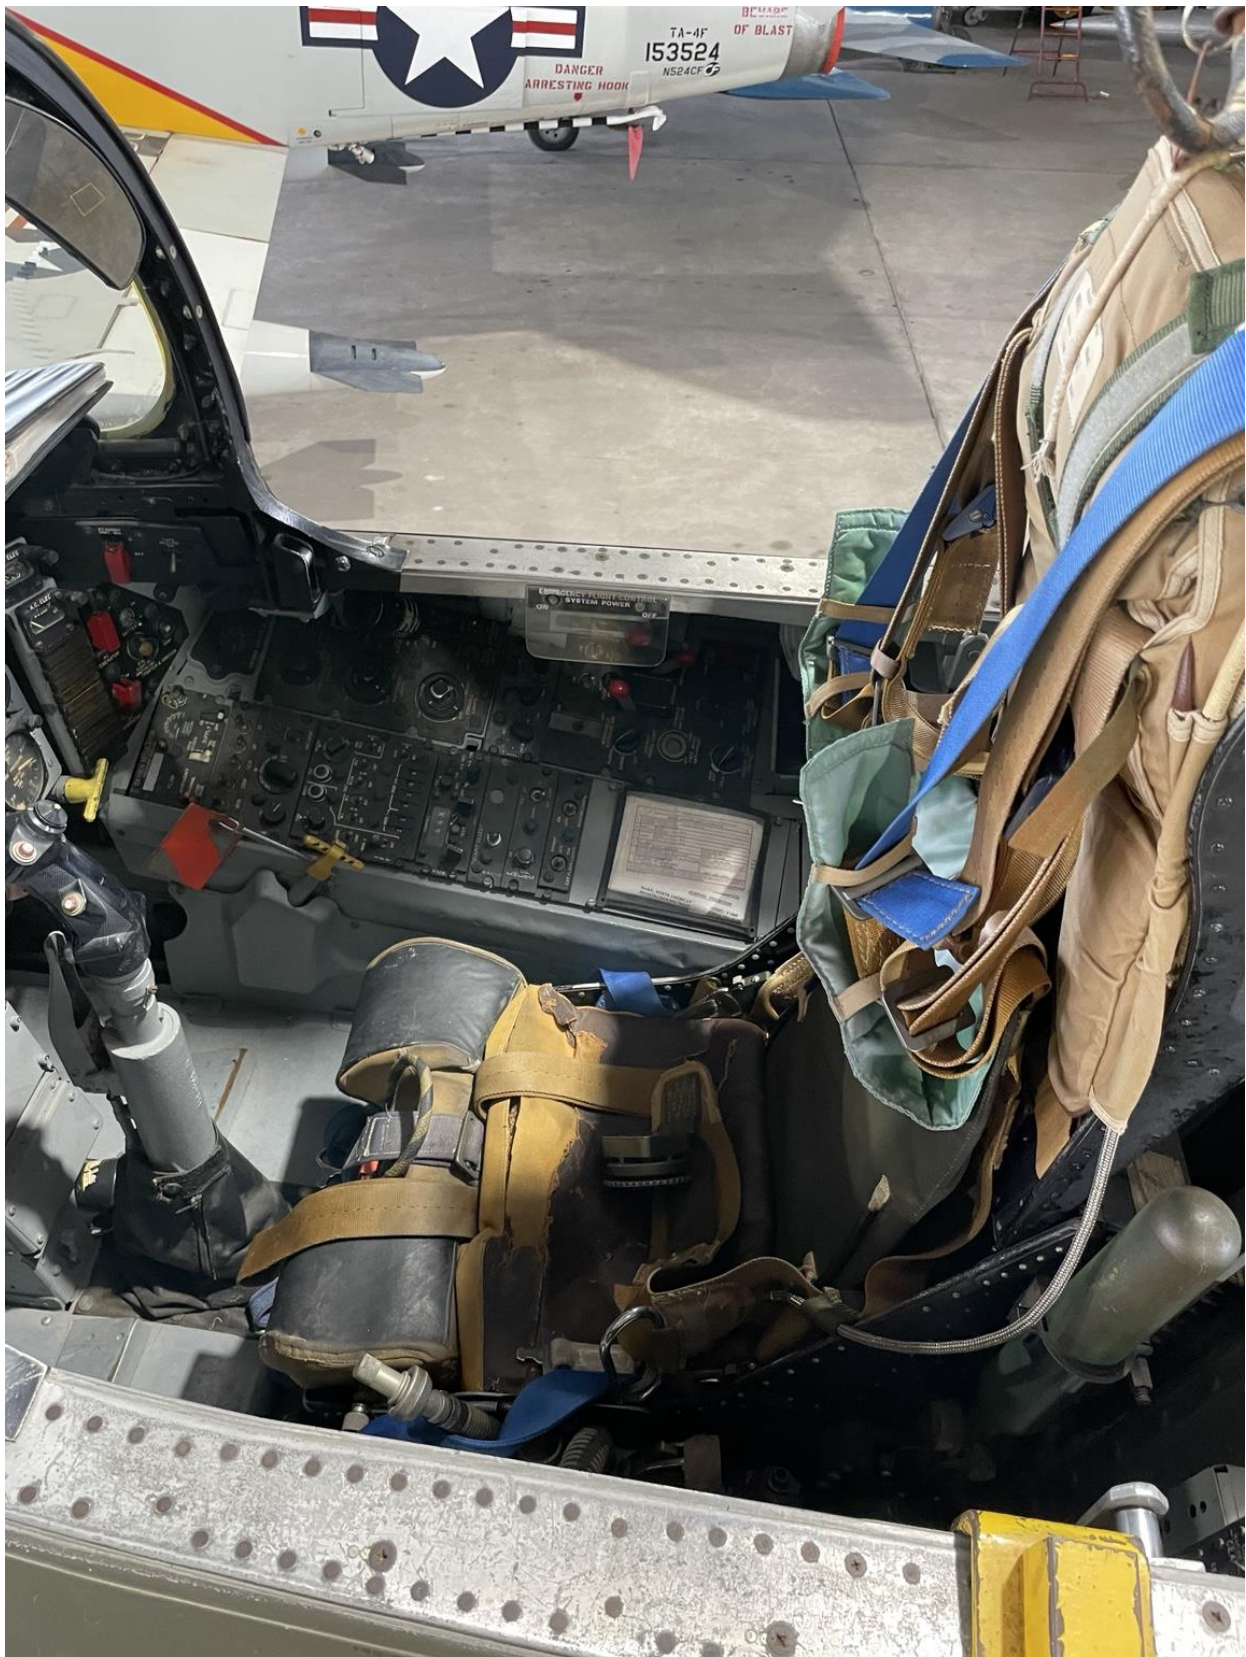
## PHOTO A — FRONT COCKPIT LEFT CONSOLE / THROTTLE ORIENTATION

ACTUAL N26AZ INSTALLATION — Front cockpit orientation. The throttle is on the left console. The panel visible at upper right is labeled "EMERGENCY FLIGHT CONTROL SYSTEM POWER"; do not identify it as the battery master without aircraft-crew verification.

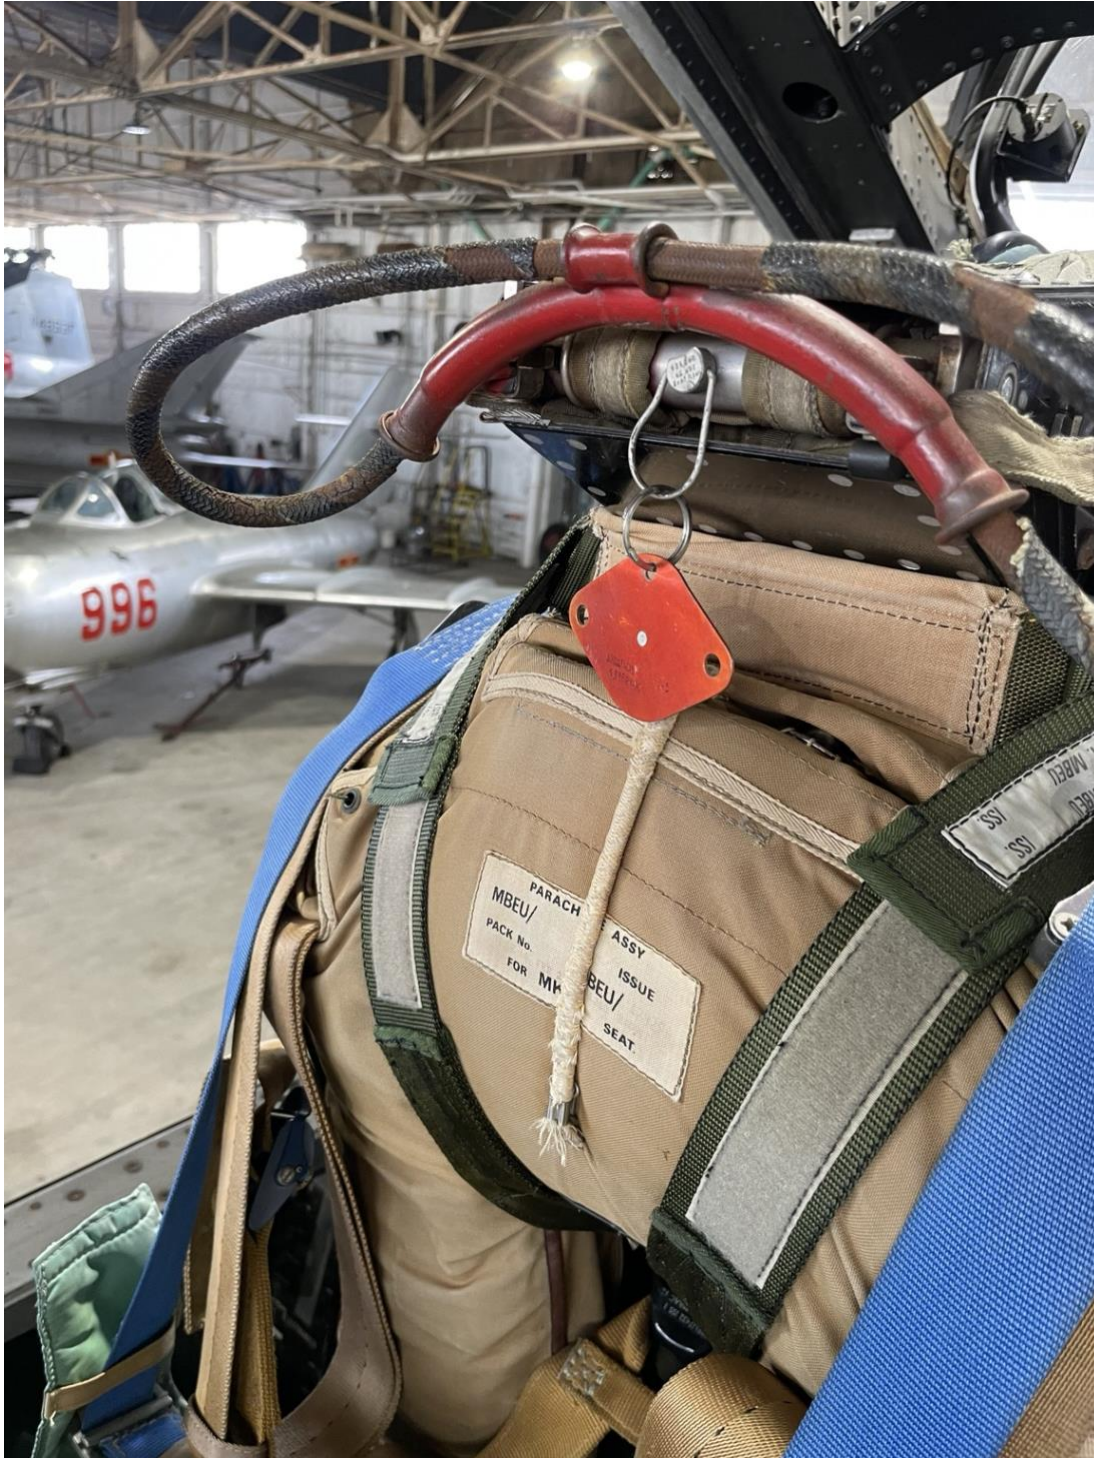
**PHOTO 4A — FRONT EJECTION-SEAT UPPER AREA / FIRING-HANDLE ORIENTATION**

*Front-seat upper area showing the prominent red handle and installed safety hardware/tag. Treat all seat components as live until positively identified and safed by the aircraft crew.*

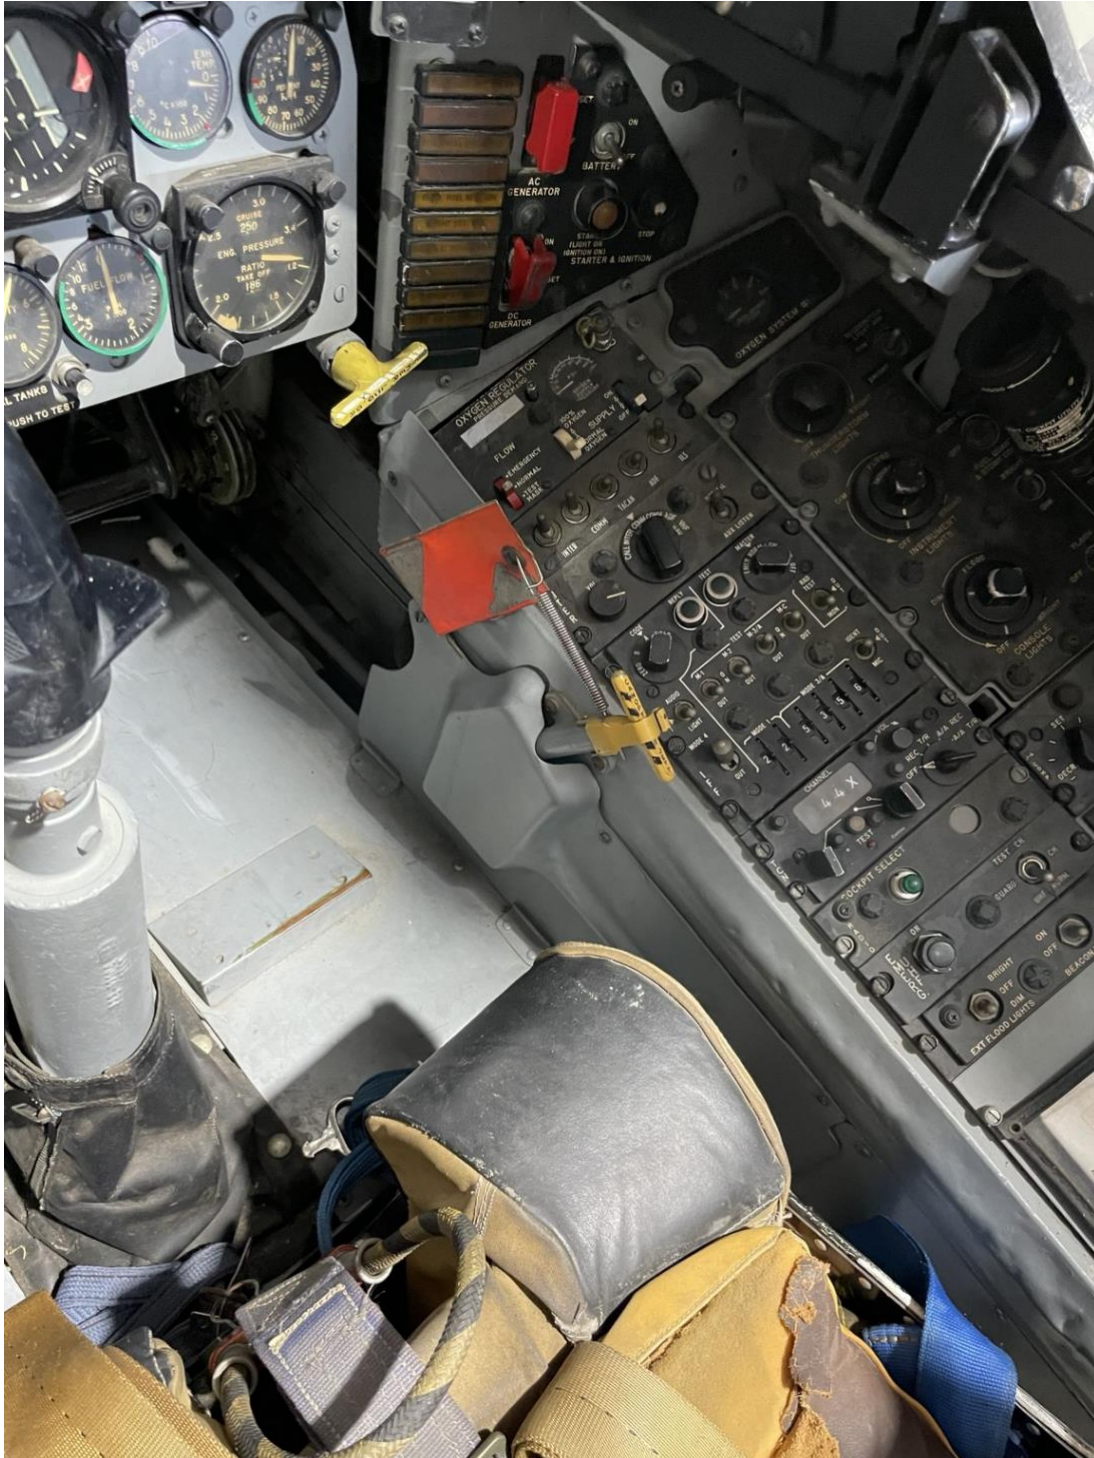
**PHOTO 4B — FRONT COCKPIT / RIGHT-SIDE SYSTEMS ORIENTATION**

*Responder orientation view of the front cockpit and right-side console adjacent to the ejection seat. The red-tagged handle circled in red is the COCKPIT CANOPY JETTISON HANDLE. This photograph also captures the cockpit BATTERY switch; see Section 3 for shutdown-control cross-reference.*

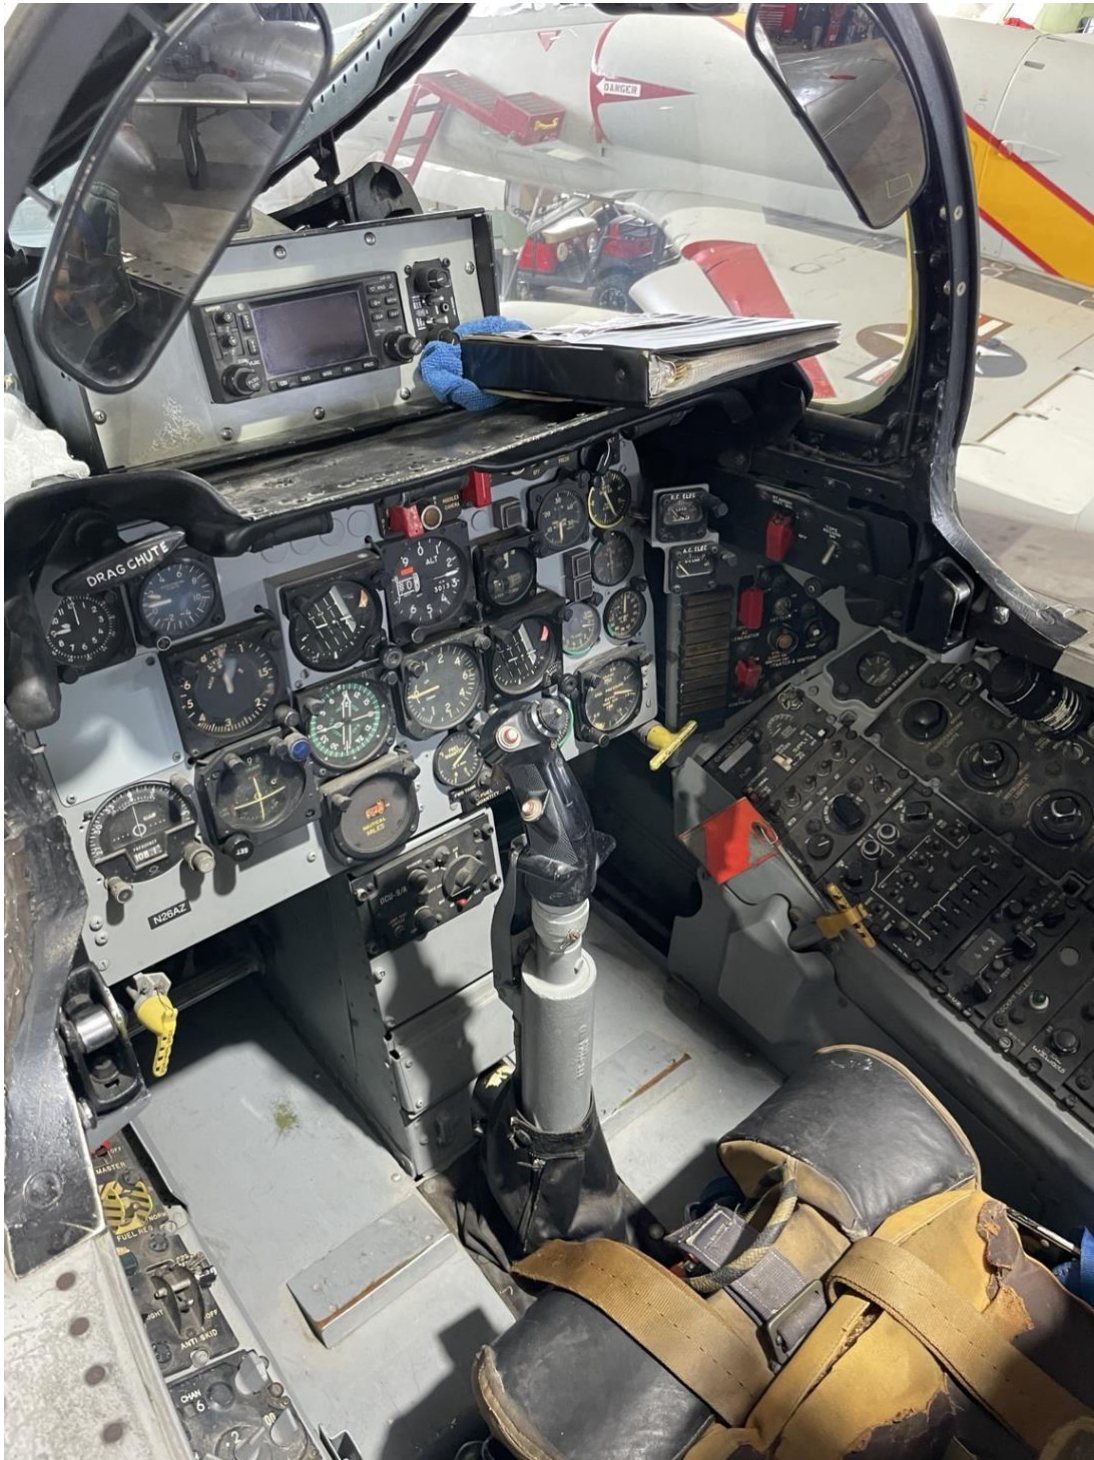
**PHOTO 4D — FRONT COCKPIT / SEAT ACCESS OVERVIEW**

*Overall front-cockpit view showing seat position, access path, instrument panel and surrounding consoles. Use for responder orientation before reaching into the cockpit.*

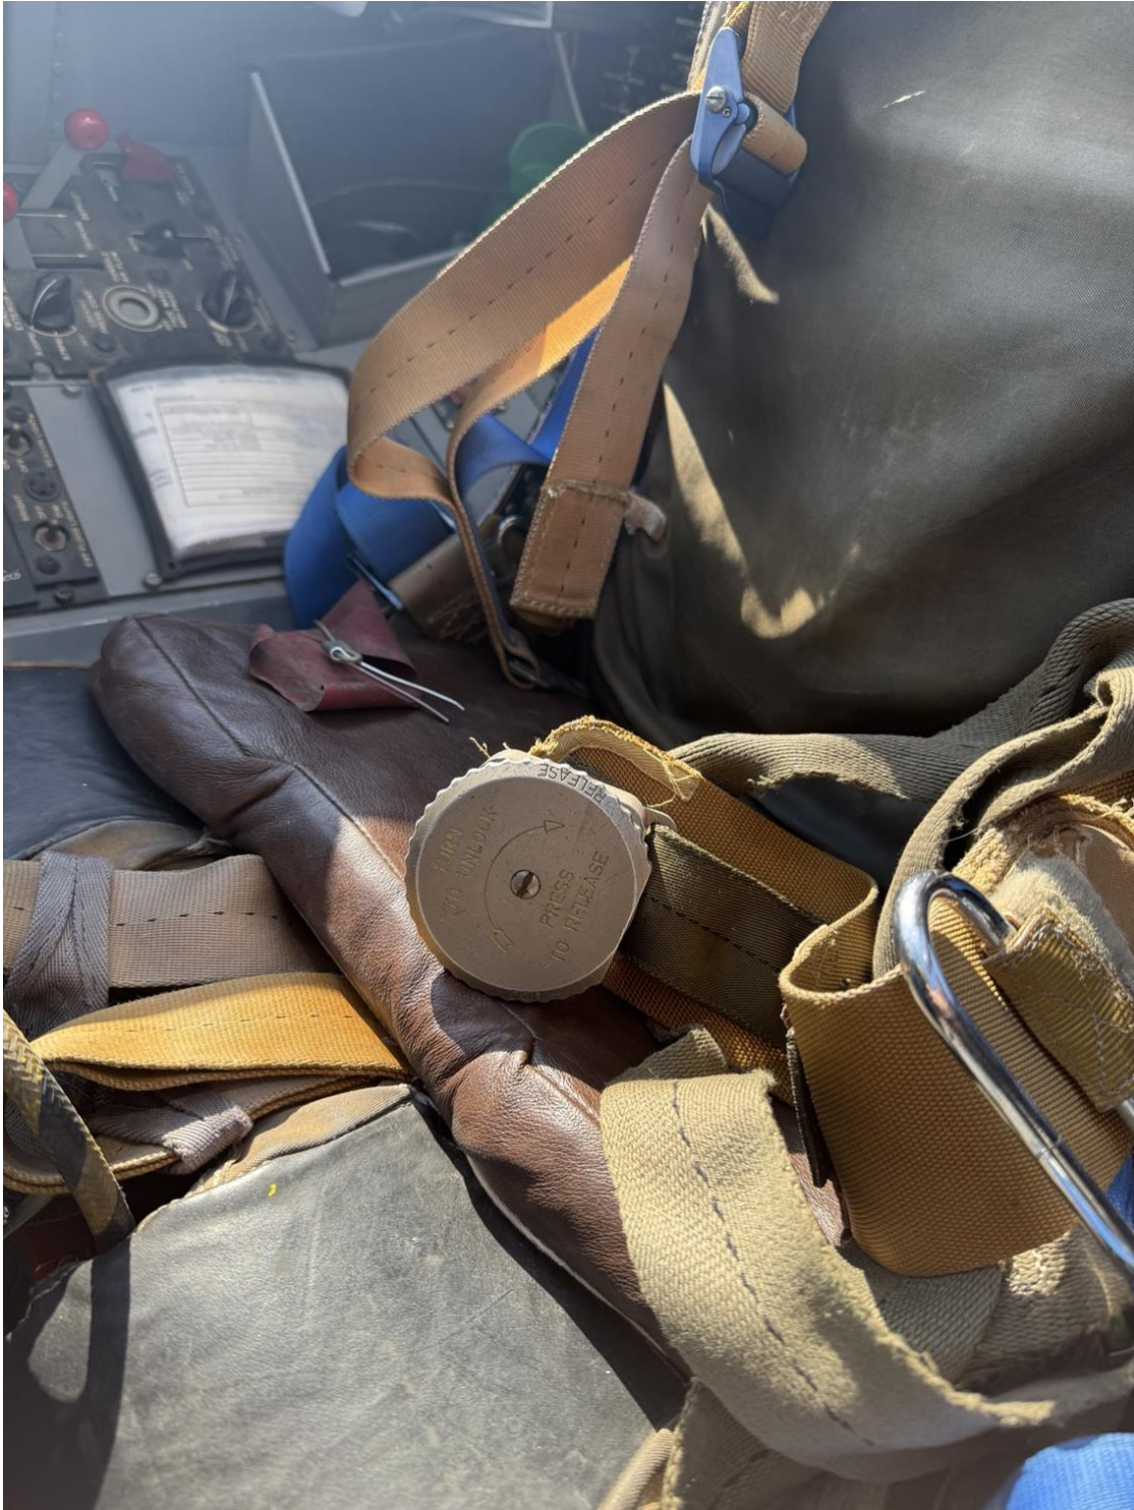
#### HARNESS RELEASE — CENTRAL RELEASE KNOB

FRONT-SEAT HARNESS RELEASE — AIRCRAFT-SPECIFIC PROCEDURE: 1) Turn the central knob to the UNLOCK position. 2) PRESS the central knob to release the harness.

1. Turn the central knob to the UNLOCK position.
2. PRESS the central knob to release the harness.

**CAUTION:** Release the harness only after the front ejection-seat system has been positively safed or otherwise rendered safe by trained personnel.

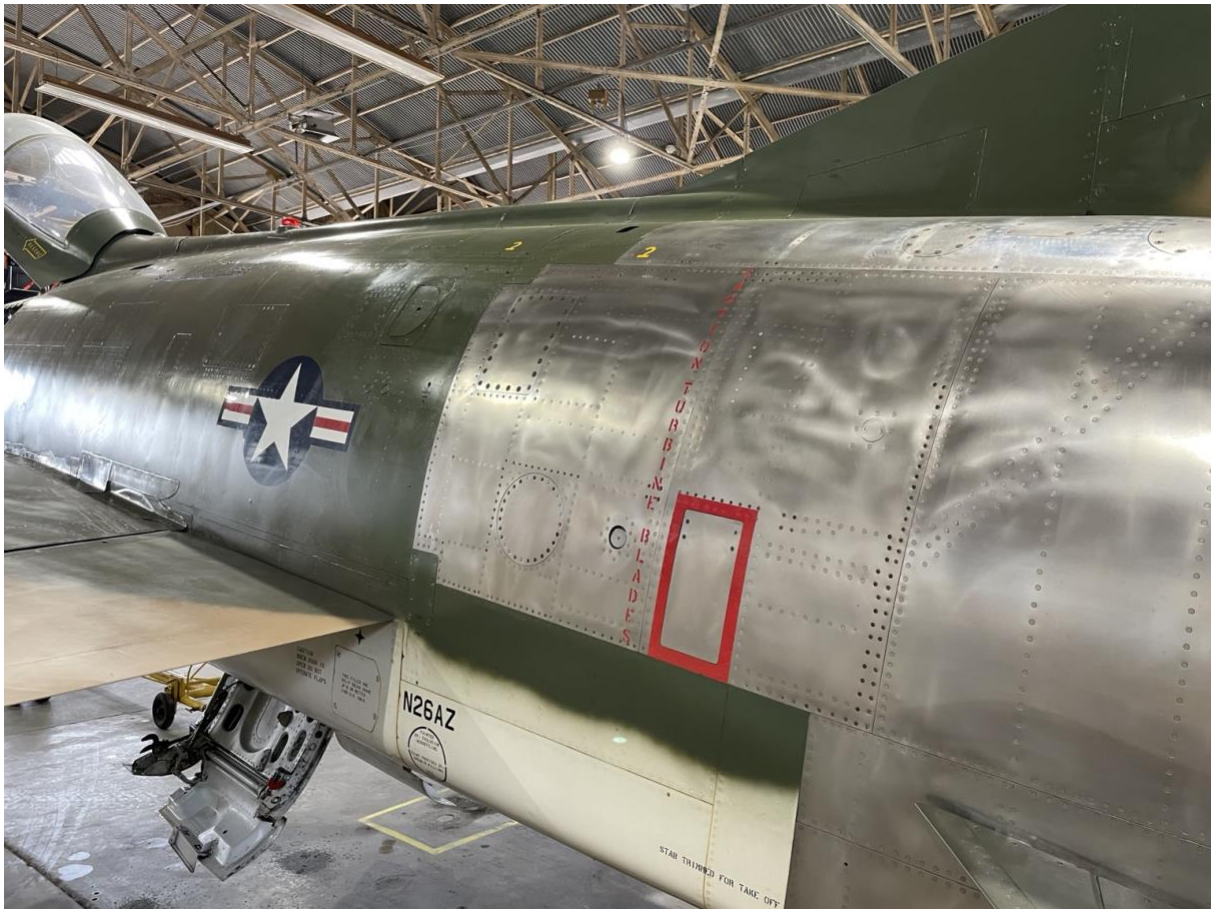
#### PHOTO A — ENGINE BAY FIRE ACCESS / FIREFIGHTING AGENT INSERTION POINT

**FIREFIGHTING ACCESS:** The red-outlined square panel on the shiny aft fuselage is spring-loaded. Depress the panel inward to insert firefighting apparatus into the engine area.

*Aircraft-specific feature confirmed on N26AZ.*

**Historical USAF rescue guidance warns against penetrating the RIGHT engine bay because of concentrated electrical wiring and hazardous substances. Verify current routing and clearly mark the N26AZ no-cut area.**
